GO Number	S/A Number	Page 1 of	Total Pages	Rev. Ltr/Chg. No. See Summary of Chg.	Number
97055	31170	145	145	NEW	EID-06141
Program Title Closure of ETEC (R21-RF)					
Document Title Hot Laboratory Decontamination and Dismantlement Final Report					
Document Type Engineering Information Document			Related Documents		
Original Issue Date 11/13/01		Release Date RELEASE 11/27/01 TV		Approvals Date	
Prepared By/Date D. W. Kneff D. M. Trippeda		Dept. 117 117	Mail/Addr T038 T038	R. D. Meyer	
IR&D Program? Yes <input type="checkbox"/> No <input checked="" type="checkbox"/> If Yes, Enter Authorization No.					
Distribution			Abstract

*	Name	Mail Addr.		<p>The former Rockwell International Hot Laboratory, located at Boeing Canoga Park's Santa Susana Field Laboratory in Ventura County, California, operated under Department of Energy funding from 1959 until 1987. It was used originally for the disassembly and examination of irradiated nuclear reactor fuel assemblies and test specimens, and later for the decladding of irradiated plutonium-bearing fuels from off-site reactors. Decontamination and decommissioning (D&D) of the facility was initiated in 1987, and facility dismantlement was complete

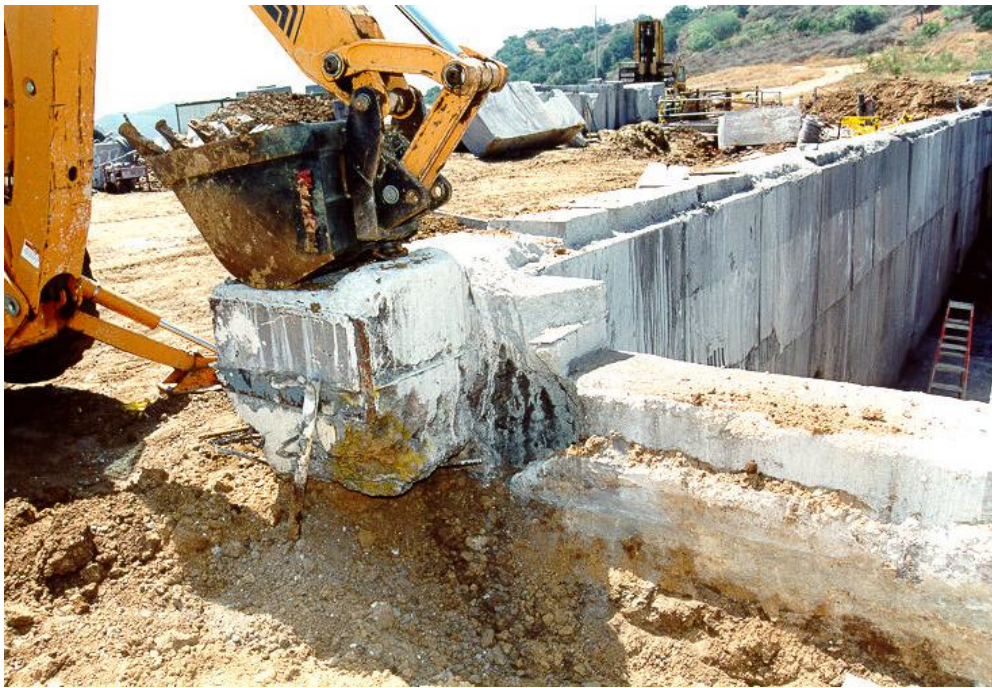
Figure 6-77. Contaminated Soil Excavation at the Base of a Concrete Seam. [ETEC-7/21/97-395190]

The second contaminated soil location was an area of expected contamination in a seam between two concrete slabs in the service gallery area, adjacent to Cells 1 and 2. Contamination in the seam area had been fixed previously to keep it from migrating. Once the foundation and facility floor slab were removed, it was discovered that the seam between the slabs was open to the underlying soil. Contaminated water from routine cleaning of the area during facility operations

had migrated through this seam and into the top few inches of soil. This was similar to soil contamination found previously under seams in the floor slab in the hot slave repair shop area. Construction seams in the floors or at wall-floor joints were the major source of contamination in the soil beneath the Hot Laboratory facility slab.

The third area of radiologically contaminated soil was found in a seam between the north cell wall and the floor below the Cell 4 fuel transfer port. Fuel transfer casks had been mated to the port during normal facility operations for fuel package transfer into the cell. Contaminated water from the fuel transfer casks, and from facility decontamination activities, had leaked through the seam. Approximately 4 cubic yards of contaminated soil were excavated from this area. Contaminated soil excavation at the base of one of the concrete seams is shown in Figure 6-77, where the light-colored concrete stains are the water pathway. The contaminated soils were removed from all three areas, which were then surveyed and free-released by Radiation Safety.

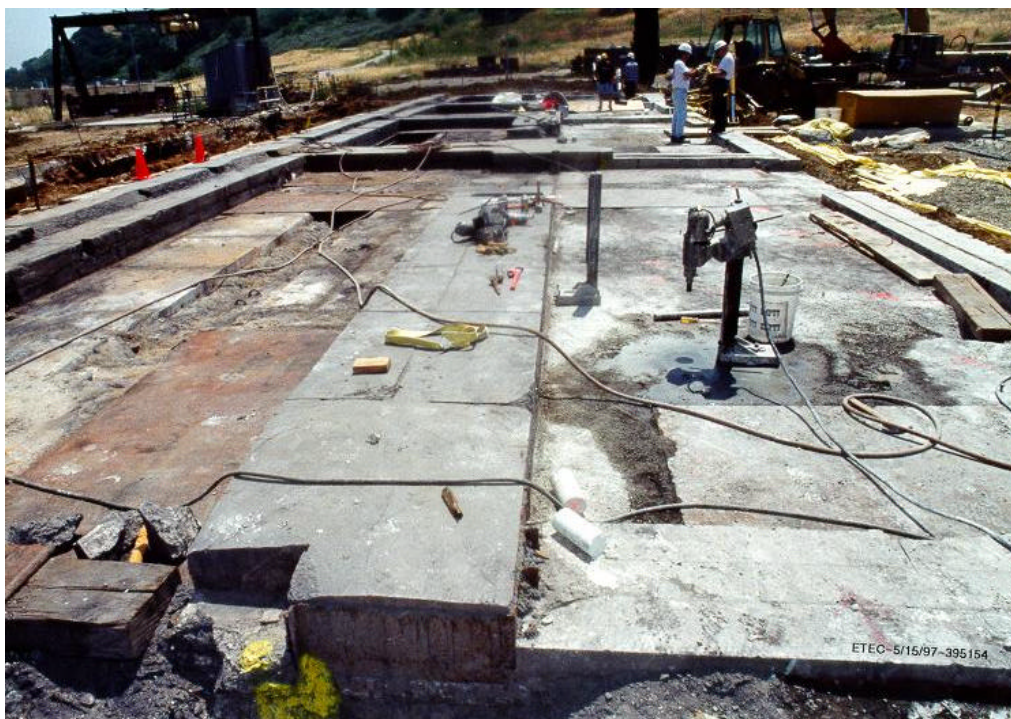
Figure 6-78. Core Drilling of the Basement Roof in Preparation for Diamond Wire Cutting. [ETEC-5/15/97-395154]

The basement roof was sectioned by using a combination of core drilling, circular saw cutting, and wire saw cutting. Core drilling, as shown in Figure 6-78, was used first, to drill 3-inch-diameter holes through the 4-foot-thick basement roof area that had been the floor of the hot cells. Those holes were used later to feed diamond cutting wires through the roof and provided the starting point for sectioning that basement roof area by diamond wire cutting. The 2-foot-thick basement roof area, which had been the floor of the decon rooms, was then sectioned using a 48-inch diamond-tipped saw blade. The saw-cutting operation is shown in Figure 6-79. All concrete coring and cutting was preceded by surveying and decontamination of the cutting path in order to minimize the generation of contaminated dust or cooling water.

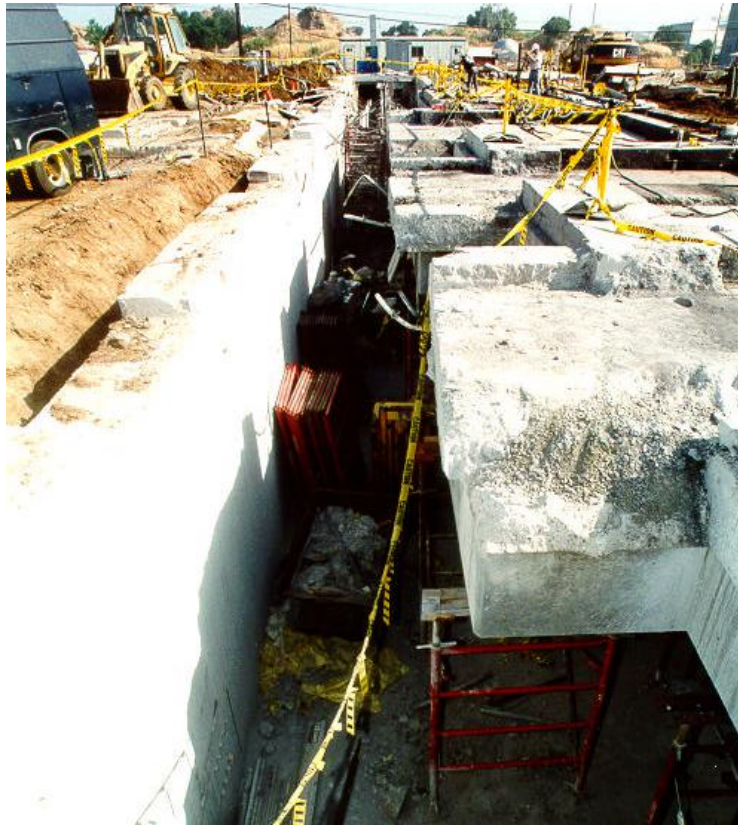
The 2-foot-thick basement roof area was cut into sections weighing up to 20,000 pounds. A large excavator was used to lift the sections and move them to the staging area. Fall protection was invoked for all crews working on the roof area, and personnel were prohibited from entering the basement while the roof was being cut and removed. Figure 6-80 shows the basement area during roof removal. HEPA ventilation of the basement became ineffective with the removal of the concrete roof slabs, and was terminated at the beginning of May 1997.

Figure 6-80. Basement Roof Removal in Progress. [ETEC-9/1/97-395327]

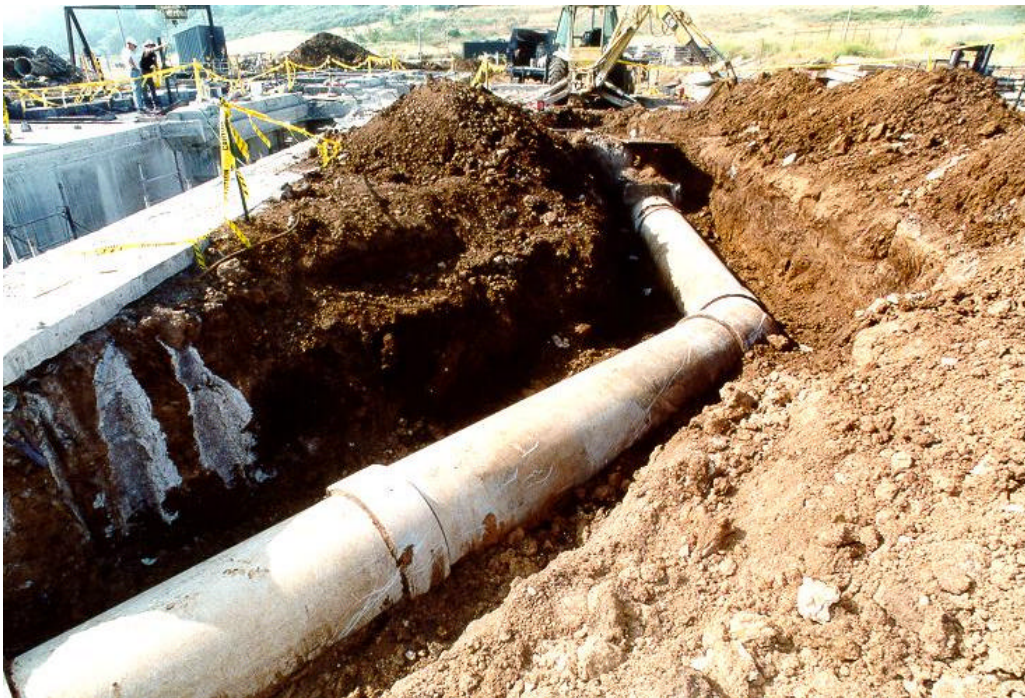
plenum, and the other was a 10-inch-diameter section that ran approximately 150 feet from the service gallery main exhaust duct past the hot storage room, air lock, and hot change room. ETEC personnel excavated around those pipe runs at the same time that the concrete contractor was saw-cutting the basement roof; Figure 6-81 shows the 30-inch-diameter pipe during excavation. The two Transite pipe runs were removed by a certified asbestos-abatement contractor with the support of ETEC personnel. They were carefully sectioned to prevent generation of friable asbestos, wrapped in plastic, loaded into approved asbestos roll-off containers, and transferred to the RMHF for size reduction by the abatement contractor. The size-reduced Transite sections were double-wrapped in plastic, loaded into roll-offs with other low-level radioactive waste (LLW), and shipped to DOE-Hanford for disposal.

Figure 6-81. Excavation of a Transite HEPA Ventilation Duct. [ETEC-9/1/97-395321]

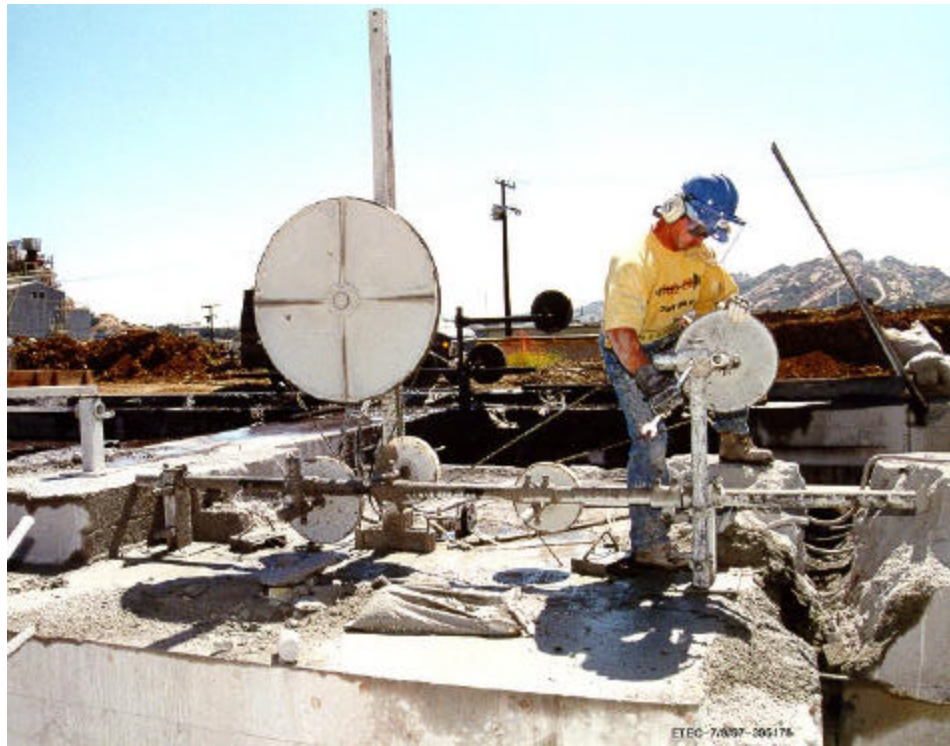
Diamond wire saw cutting was selected for sectioning the 4-foot-thick basement roof area in order to eliminate the need for personnel to work under the roof. Circular saws, used for the thinner roof areas, would have required cuts from above and below because of their maximum cut depth of 30 inches. The 3-inch-diameter core-drilled holes were used to set up the diamond cutting wires, with the wire looped through two holes and tightened as the cutting progressed. There was a significant learning curve for the contractor, with wire breakage and diamond delamination from the cutting wires occurring frequently during the first part of the work. The difficulties were caused by the high density of the concrete and the 2-inch-thick embedded steel reinforcing bars. The diamond wire sawing of the roof took about eight weeks, which was five weeks longer than originally estimated. Figure 6-82 shows a typical wire saw setup, and Figure 6-83 is a photograph of the basement area following roof removal.

Figure 6-82. Typical Setup for Diamond Wire Sawing the Basement Roof. [ETEC-7/9/97-395178]

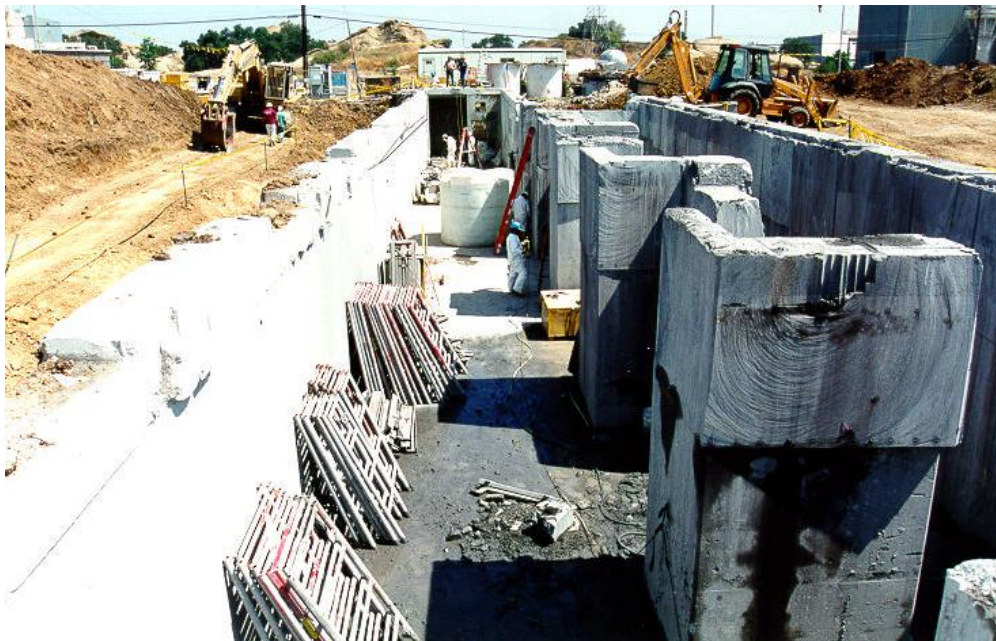
Figure 6-83. Basement Area Following Roof Removal. [ETEC-7/21/97-395196]

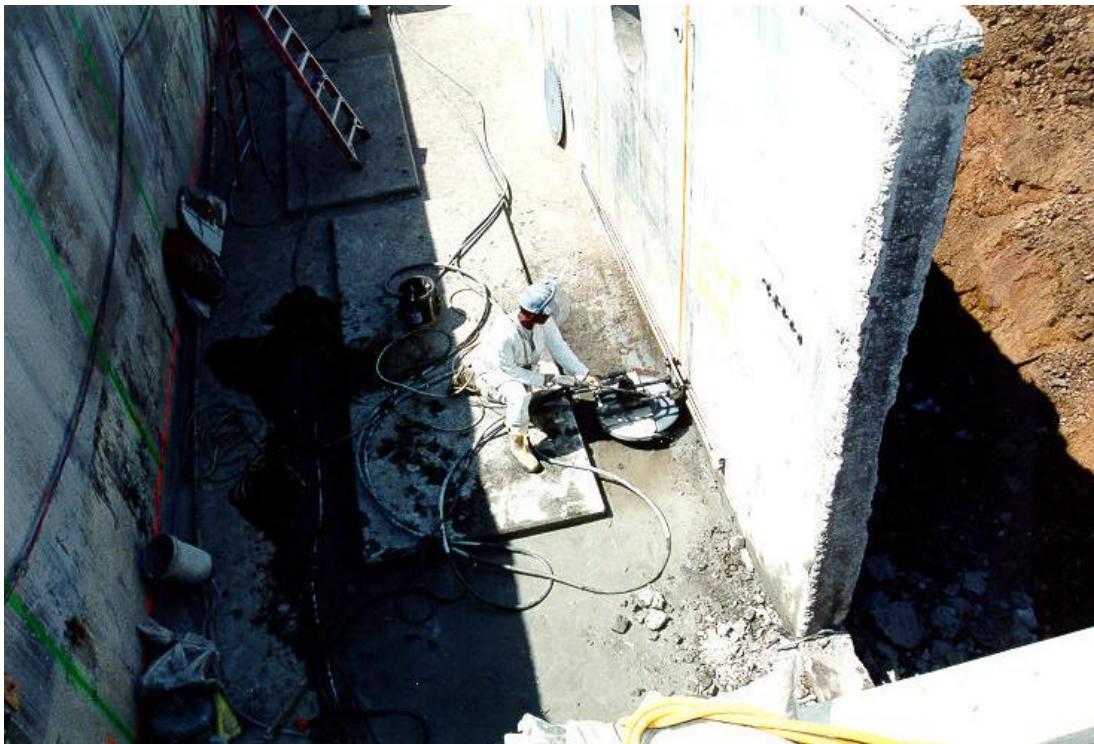
The removal of the basement roof and the excavation of the soil adjacent to the exterior of the basement wall was followed by the saw cutting of the walls. The vertical and horizontal cutting lines were first laid out, and a series of 4-inch-diameter holes were cored through the walls near the top to accommodate 1-inch wire cables for lifting and handling the wall sections. The walls were cut into 15-foot-high by 30-inch-wide sections using diamond-tipped circular saws, as shown in Figure 6-84. All saw-cut surfaces were surveyed by Radiation Safety before cutting was initiated, and most cuts were made from the inside of the basement. The cut depth was set to about $\frac{1}{4}$ inch less than the thickness of the wall to eliminate the potential for the spread of radiological contamination from saw blade cooling water spray. The cutting contractors were also instructed to leave approximately 4" of wall at the base to act as a barrier to hold contaminated water inside the basement. Management of the cutting water was a critical task to prevent radioactive contamination from migrating outside of the basement area. ETEC personnel washed down the cut wall sections to remove any loose contamination and collected and packaged the concrete slurry and concrete rubble that accumulated on the basement floor from the cutting operations.

Figure 6-84. Saw Cutting of the West Basement Wall. [ETEC-7/21/97-395186]

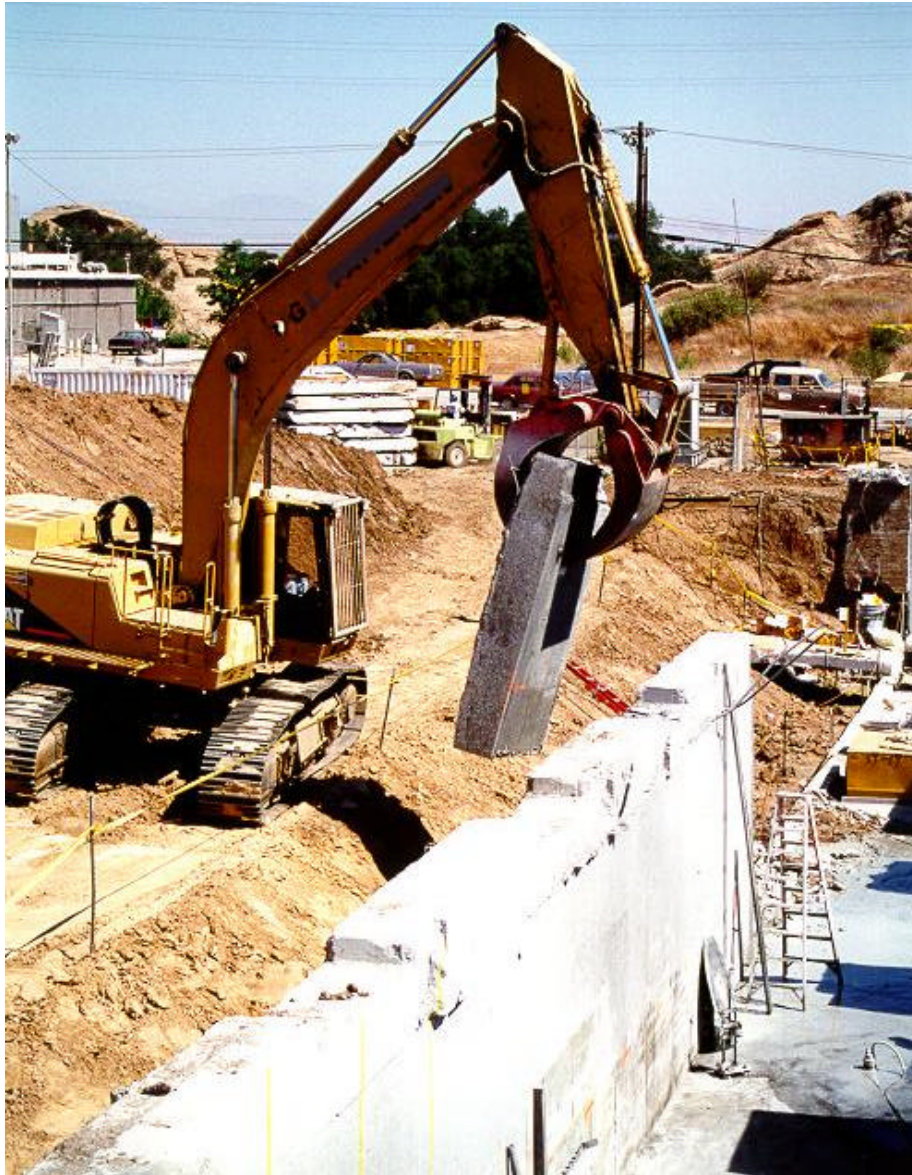
When the cutting of each wall section was complete, it was removed by a heavy excavator, as shown in Figure 6-85. Each section was snapped off by the excavator without cutting through the final $\frac{1}{4}$ " of wall thickness. The individual sections were transported to a holding area for a detailed survey and decontamination by ETEC crews. Each section measured approximately 6 feet x 12 feet in area and had a thickness of 1 foot or 2 feet, depending on its basement location. Slab weights ranged from about 11,000 lb. to 22,000 lb.

Figure 6-85. Removal of a Basement Wall Section Using the Excavator. [ETEC-8/4/97-395240]

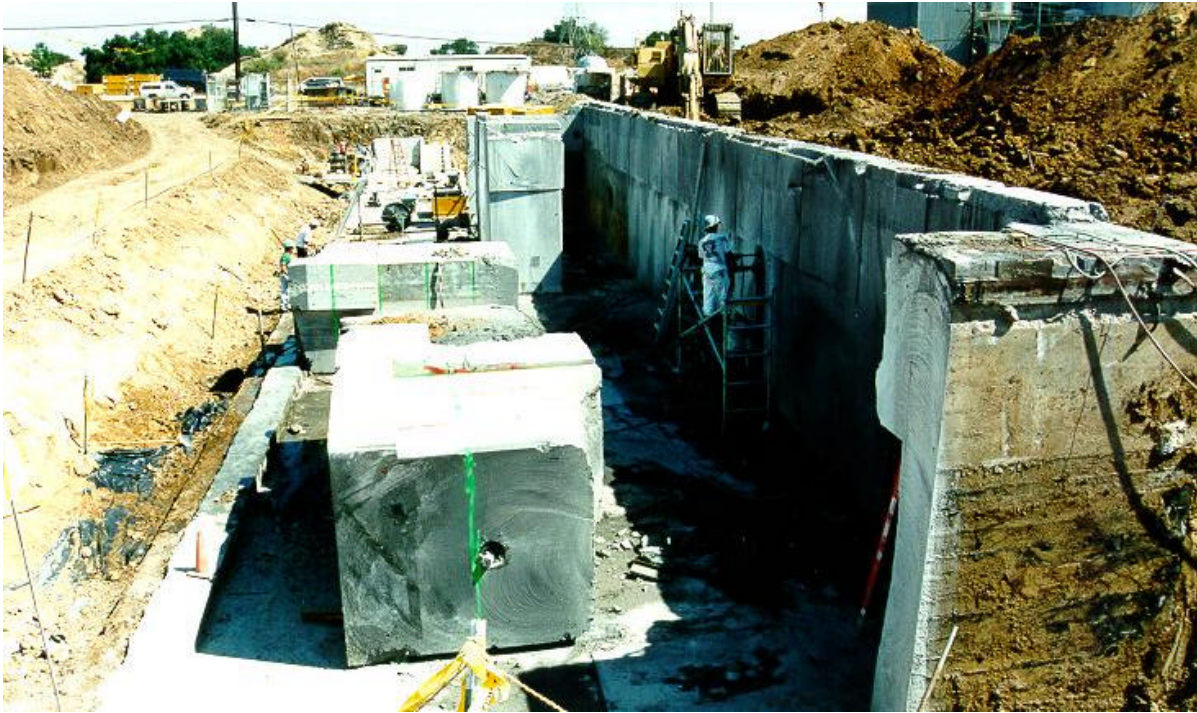
The large high-density concrete support columns, which supported the cell floor, were sectioned using a diamond wire saw because of their large size. This also proved to be a difficult wire-saw cutting task, because of the large number and size (up to 2-inch diameter) of embedded steel reinforcing bars. Each column was cut into four sections because of its weight, with the first cut made at the base and the remaining cuts with the column lying on its side. This made it easier to cut through the steel reinforcing bars and maximized the effectiveness of the cutting water in removing cutting fines and maintaining a clear cutting surface. Figure 6-86 shows two of the basement columns after they had been cut off at the base and laid down for size reduction.

Figure 6-86. Two Basement Support Columns Cut Off and Ready for Size Reduction. [ETEC-8/25/97-395290]

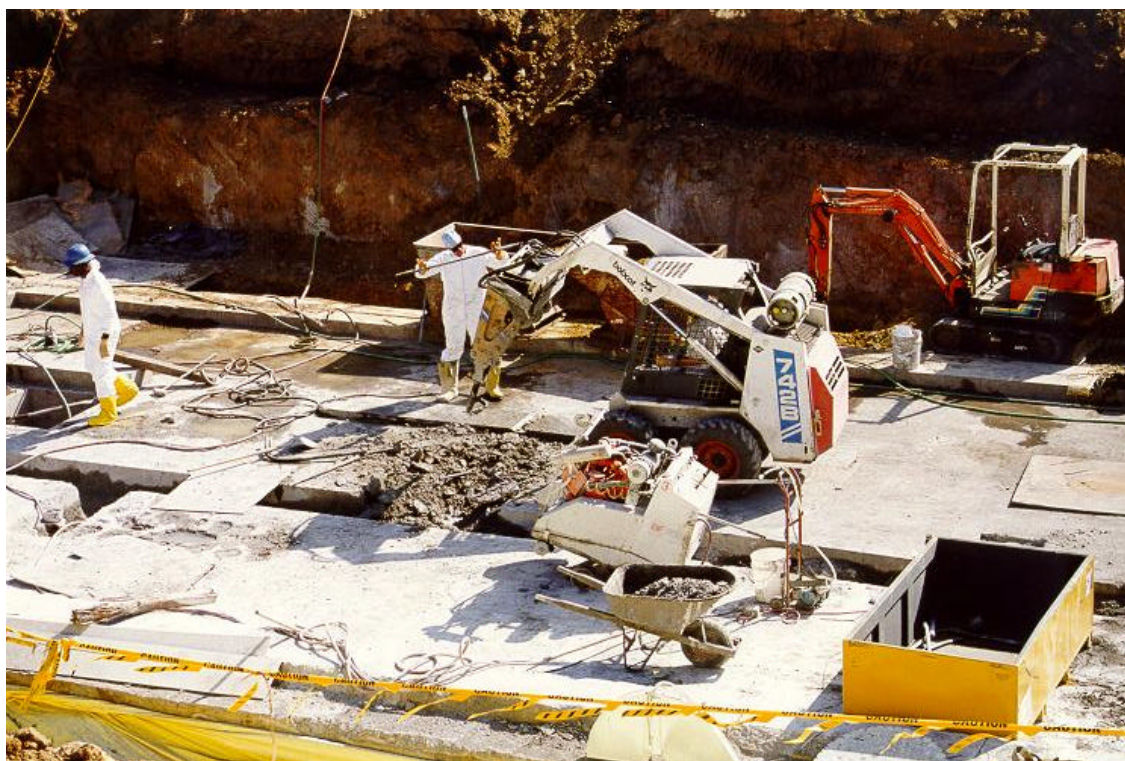
The final stage of basement demolition was the removal of the floor drains and the concrete floor slab. The floor drains were the largest potential source of radiological contamination and the source of the highest exposure levels in the basement. The cleaning and removal of the drain lines had been initiated before the basement demolition was started, including the flushing of the lines and sumps, the plugging and capping of drain inlets and discharge points, and the paint-sealing of the sump surfaces. With the basement walls now removed, ETEC personnel saw-cut 18-inch-wide trenches in the floor to expose the drainage system beneath the concrete slab. The work was expedited by the use of a tractor-mounted hi-ram to break up the trench-area concrete and a small backhoe tractor to perform most of the trench excavation. The use of the hi-ram is shown in Figure 6-87. Radiation Safety personnel monitored exposure levels continuously as segments of the underlying drain line system were exposed. The drain line was sectioned as it was removed, the section ends were sealed, and the sealed components were transferred to the RMHF in standard waste containers for clean out and isotopic analysis.

Figure 6-87. Removal of the Concrete Slab Above the Drain Lines. [ETEC-9/22/97-395358]

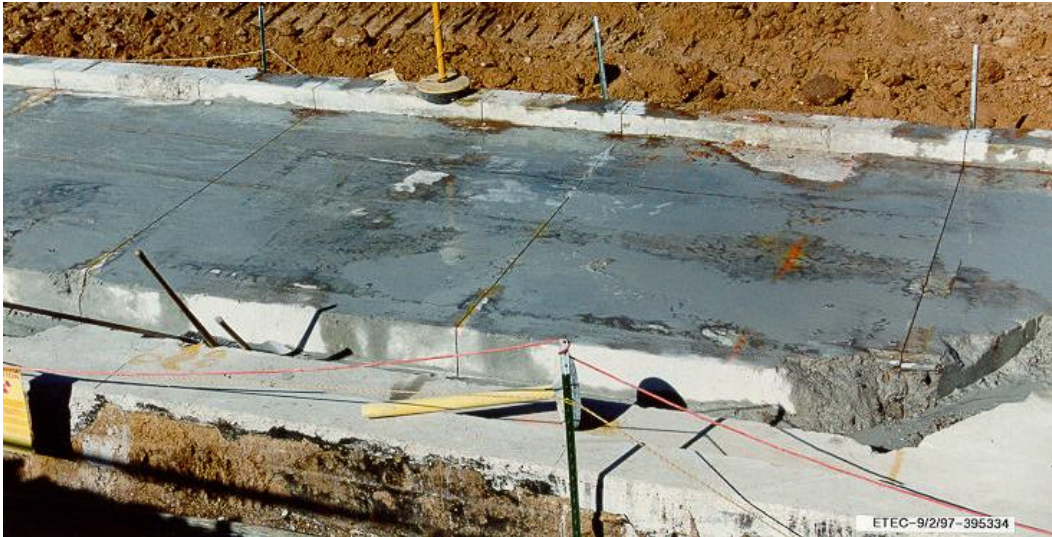
Following removal of the drain system from the basement area, the remaining floor slab was surveyed and additional areas were decontaminated. An outside contractor then saw-cut the slab into sections that were approximately 6 feet wide by 10 feet long, as shown in Figure 6-88 for the basement tunnel area (that area previously occupied by the facility HEPA ventilation duct room; see Figure 2-4). A major consideration in this cutting operation was the capture of the saw-cutting water to avoid the potential spread of contamination. Approximately 3,500 gallons of waste water was generated in a typical week of horizontal saw cutting of thick concrete.

Figure 6-88. Tunnel-Area Basement Slab Following Saw Cutting for Removal. [ETEC-9/2/97-395334]

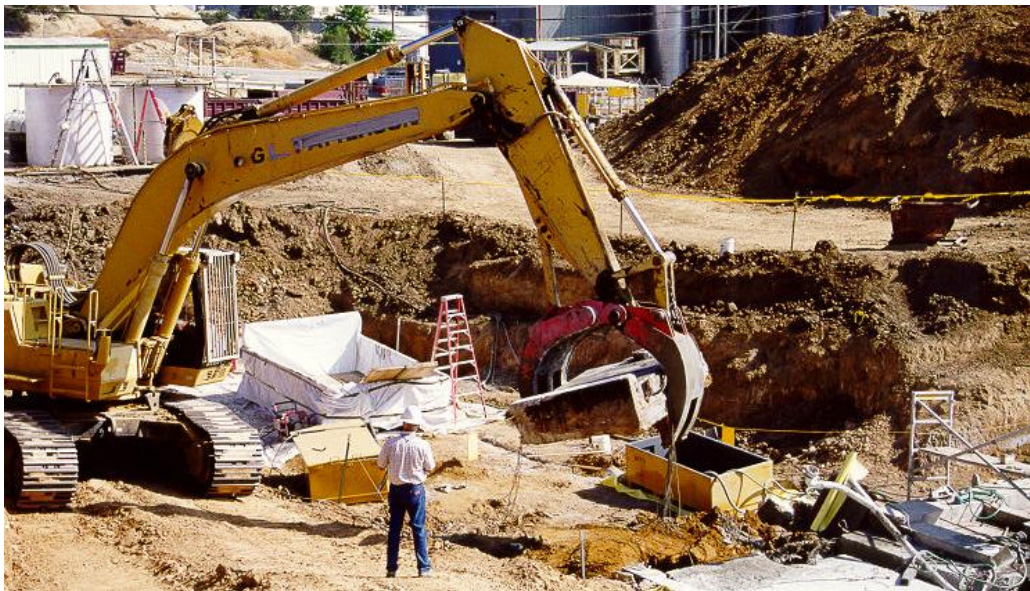
The basement slab sections in the tunnel area, where the slab thickness was 2 feet, were removed by a large excavator, as shown in Figure 6-89. The first slabs removed were washed down in a large tub, also shown in Figure 6-89, to remove loose contamination. However, that procedure became too time consuming to meet schedule requirements, and the subsequent slab sections were set aside for later decontamination.

Figure 6-89. Removal of the Tunnel-Area Basement Slab Sections by Large Excavator. [ETEC-9/22/97-395363]

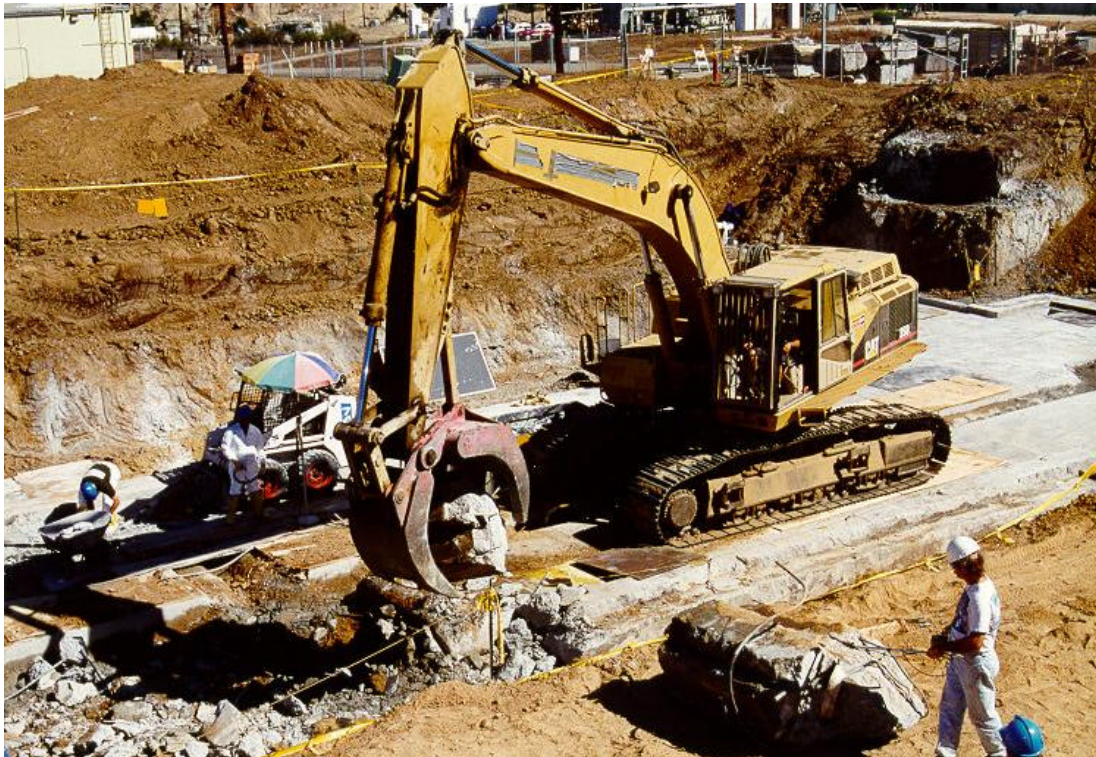
Removal of the basement slab sections in the area of the five support columns (under the facility hot cells) was significantly more difficult, as the concrete was 3 feet to 4 feet thick instead of the 2-feet-thickness specified in the as-built facility drawings. With the saw cuts only 24 inches deep, the contractor found it easier to break the thicker floor sections loose using the weight of the 70,000-lb. excavator. A layer of ½-inch-thick plywood was placed on the slab to avoid contamination of the excavator track drive, and the excavator was used directly over the slab to pull up the concrete. That operation is shown in Figure 6-90. This also proved to be difficult, because of extensive steel reinforcement bars embedded in the concrete, and the concrete broke up as it was removed. In some locations, holes were drilled in the concrete and filled with Brite-Star, an expanding chemical grout, which was allowed to cure overnight and generate fractures in the concrete. The reinforcing steel was then hand-cut using a cutting torch. This process was very slow, and was subsequently replaced with the use of an excavator with a large hi-ram to reduce the final approximately 30% of the slab area to rubble. The resulting concrete and steel debris were placed in roll-off containers and waste boxes for disposal as low-level radioactive waste.

Figure 6-90. Removal of the Thick Portion of the Basement Slab. [ETEC-10/1/97-395382]

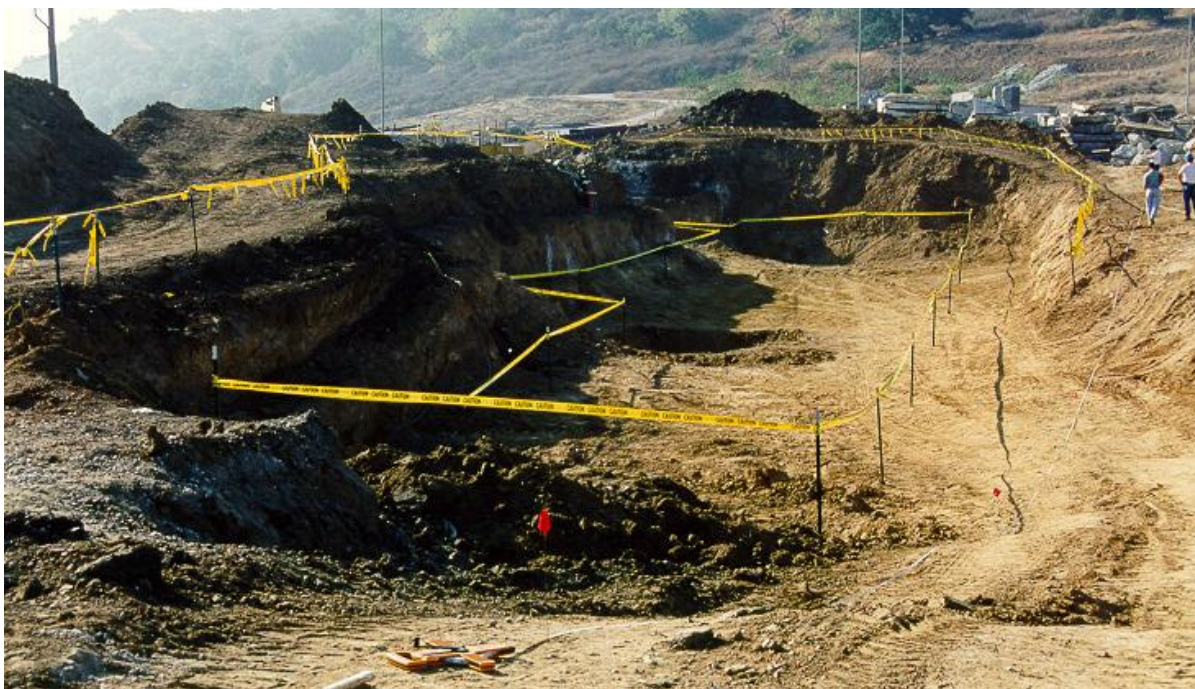
The demolition of the facility basement was completed at the end of FY 1997. The detailed final radiological survey of the excavation, shown in Figure 6-91, and the surrounding site area by Rocketdyne Radiation Safety personnel was performed in parallel with the basement removal, and included the collection and analysis of soil samples. The excavated area was verified by Rocketdyne to be radiologically clean at the end of FY 1997.

Figure 6-91. Hot Laboratory Site Ready for Verification Surveys. [ETEC-10/20/97-395401]

The FY 1998 Hot Laboratory site activities were initiated with a independent on-site verification surveys by the Oak Ridge Institute for Science and Education (ORISE) and the California Department of Health Services (DHS) Radiological Branch on October 1, 1997. ORISE is an organization used by the DOE to perform independent third-party release surveys. The surveys included the collection of duplicate soil samples. ORISE issued a written report in January 1998 providing independent verification that the excavated area was radiologically clean (*Ref. 1*).

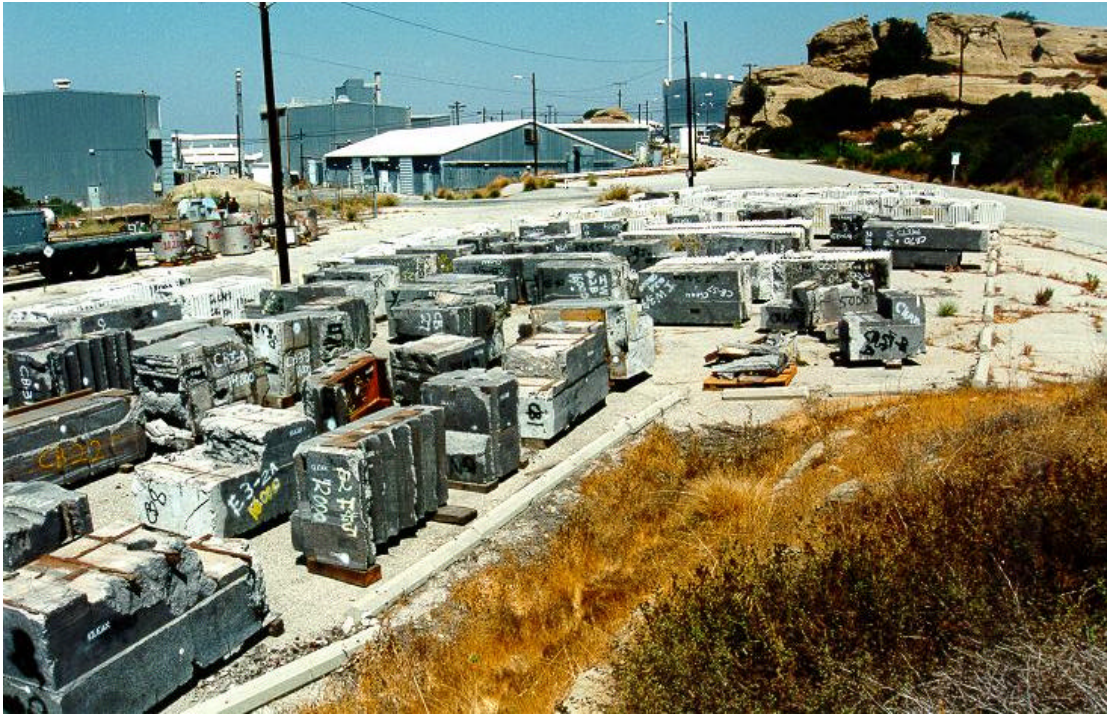
Concrete block decontamination to minimize low-level radioactive waste disposal quantities had been initiated in FY 1996. That initial experience led to the development of a general rule that it was not cost-effective to decontaminate a block for which contamination was present on more than 30% of its surface area. The procedure developed was to first identify the extent and location of contamination on each block. Those blocks with less than 30% surface contamination were decontaminated, while those with greater contamination were size-reduced to manageable weights and shipped to designated DOE sites for disposal. Some of the disposed block sections were double-wrapped in plastic for shipment intact, while others were reduced to rubble and shipped in roll-off containers for disposal as bulk waste. The decontaminated blocks were surveyed and released by Radiation Safety and staged in a holding yard, as shown in Figure 6-92, pending a confirmation release survey by the California DHS. Approximately 200 blocks were released for unrestricted use during 1997 and subsequently shipped off site for use in land reclamation projects.

Figure 6-92. Holding Yard for Clean Concrete Block Sections. [ETEC-7/21/97-395192]

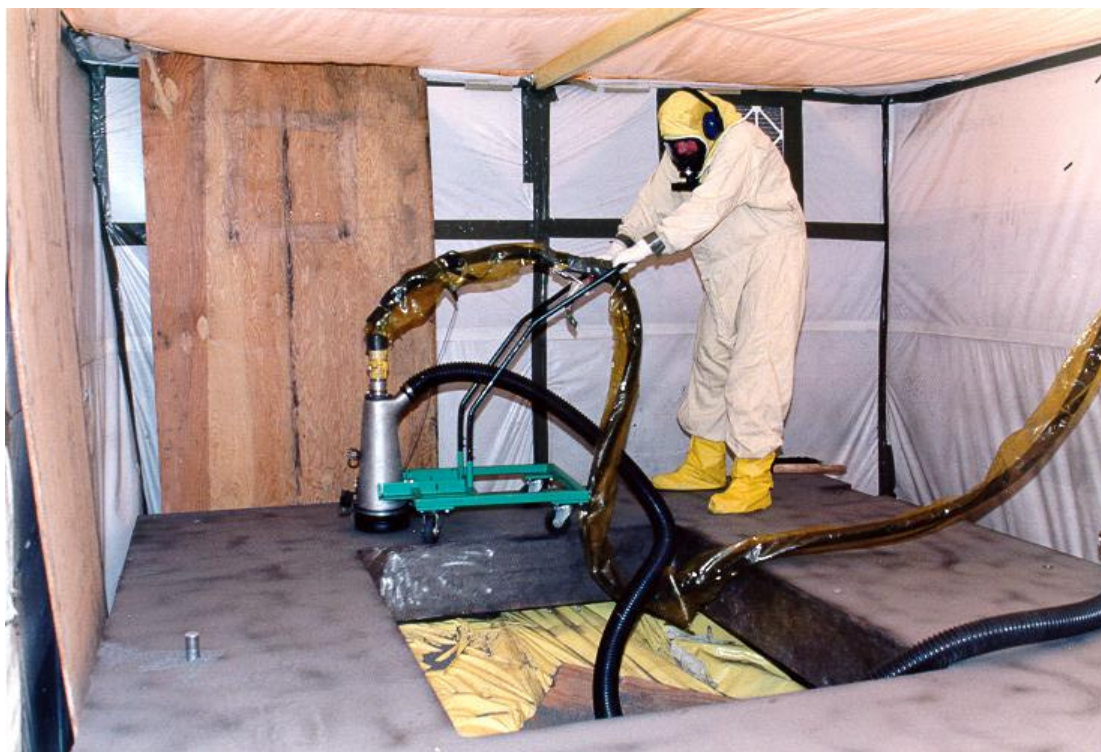
The shield doors became a major challenge in handling, decontamination, and final disposition. The doors weighed between 32 and 44 tons each and were made of cast Meehanite®, a dense, fine-grained cast iron. A decontamination sequence was developed that involved a series of steps, including surface paint removal, surface decontamination, decontamination of recessed features, size reduction, and recycling. Decontamination was performed in Building 4022 at the RMHF, a former dry fuel handling facility that has a 50-ton bridge crane capable of handling the doors. A special HEPA-ventilated containment enclosure was fabricated that could be moved and placed over one door at a time. Figure 6-93 shows surface decontamination in progress in the enclosure using a cart-mounted grit blast head.

Figure 6-93. Shield Door Surface Decontamination by Grit Blasting. [ETEC-4/19/97-395081]

Decontamination was initiated by paint removal using hand-held needle scalers, which was effective but extremely labor intensive. The needle scalers were replaced by the use of a large commercial steel-shot grit blast machine which incorporated an abrasive recovery/re-use system that effectively removed the paint and minimized the quantity of contaminated abrasive produced. The abrasive blasting uncovered casting irregularities along the door edges that allowed contamination to leech into the surfaces, and further aggressive abrasive blasting was ineffective in its removal. Attempts were made to remove the spot subsurface contamination using hand grinding and a magnetic-based drill press; they were successful but extremely labor intensive. A portable end mill was subsequently rented and adapted to a specially designed mounting fixture. This fixture allowed the milling machine to remove up to ¼ inch of contaminated material from the door edges without moving the door. After completion of the milling operation, shown in Figure 6-94, approximately 90% of the door surfaces had been successfully decontaminated. The remaining areas, including pockets beneath door lug pins that could not be removed, were inaccessible either for decontamination or radiological surveys.

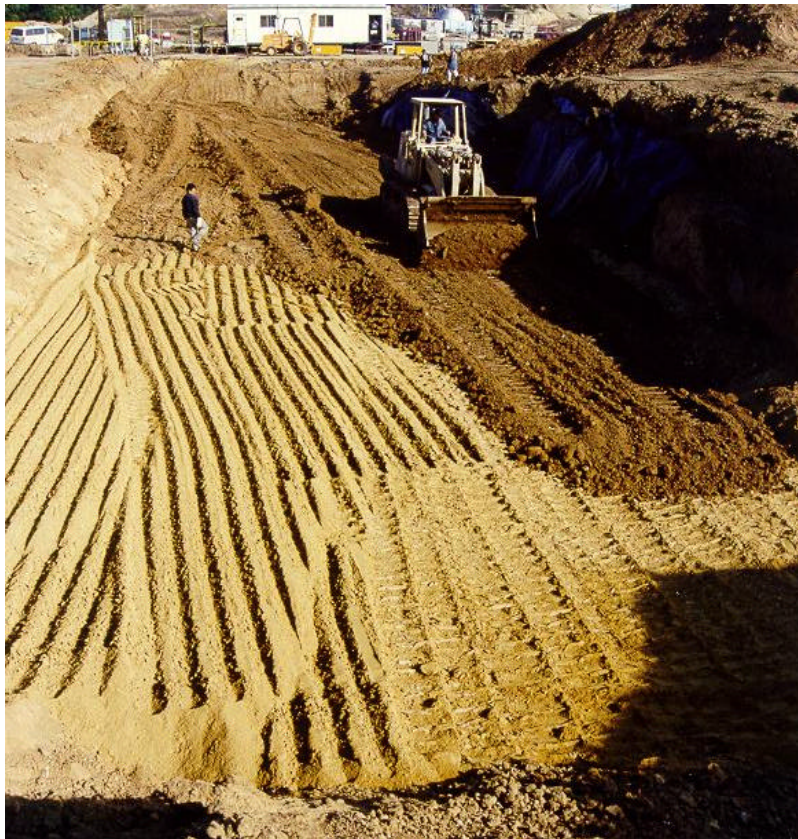
The Rocketdyne results and the initial verbal confirmation from ORISE were used to make a programmatic decision to backfill the excavation prior to the release of the official ORISE report. The purpose was to avoid having an open pit during the winter rainy season. The excavation was first lined with a 1-foot-thick layer of sand as a marker to identify the bottom of the excavation, and the area was then backfilled and compacted during the first quarter of FY 1998. Figure 6-95 shows the beginning of the backfilling operation, and Figure 6-96 shows the site at completion, including the adjacent storage of concrete block sections from the basement demolition activities. In parallel with the backfilling operation, all remaining utilities were disconnected and removed from the site, general cleanup was performed, and the site was sloped to ensure proper drainage during anticipated winter storms.

Figure 6-95. Backfilling and Compaction of the Basement Excavation. [ETEC-10/24/97-395401]

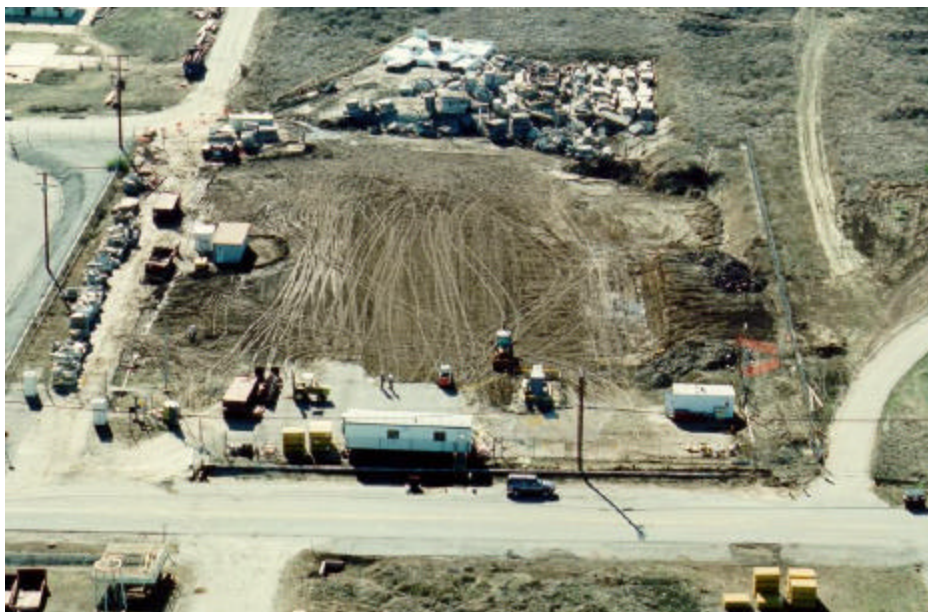
Figure 6-96. Site After Backfilling the Basement Excavation. [ETEC-11/4/97-395422]

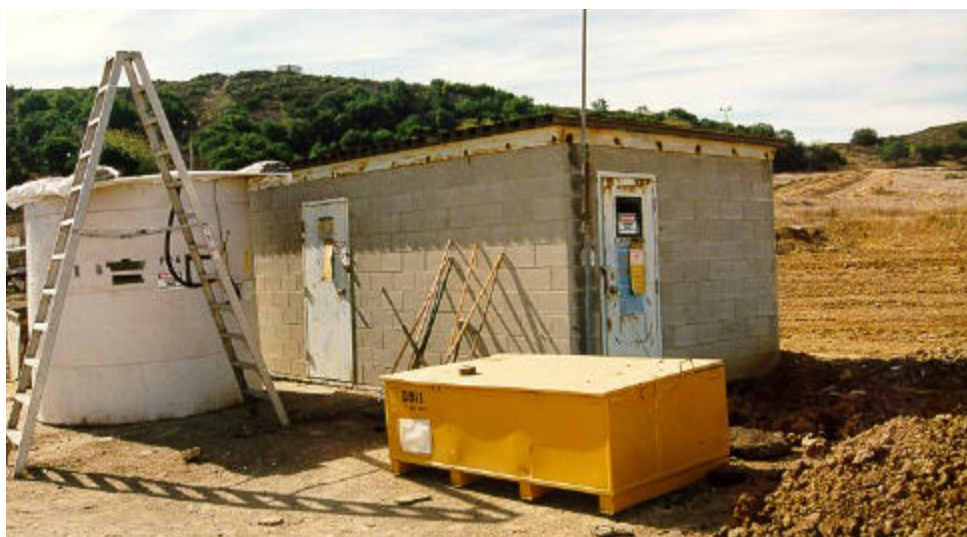
Building 4468 had housed the 3000-gallon facility radioactive drain tank, removed in FY 1994. The remaining 10-foot by 22-foot by 20-foot building (Figure 6-97) consisted of an above-ground cinder-block structure and a below-grade structure of poured concrete. The concrete extended to a depth of about 12 feet. During facility operations, groundwater seepage would occasionally fill the facility sump and overflow onto the floor. The facility was known to have radiological contamination on the lower 6 feet of the concrete walls, on the floor, and in the sump, based on facility records and survey data.

Figure 6-97. Liquid Waste Facility Building. [ETEC-11/3/97-395411]

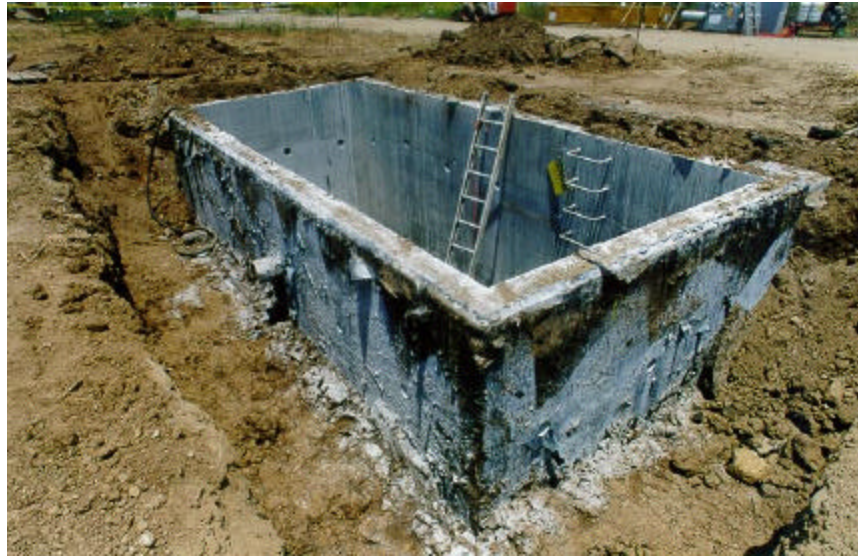
Decontamination and demolition of Building 4468 was initiated with the removal of the steel roof, a high-pressure spray wash-down of the interior surfaces, and removal of all loose contamination and liquid waste generated during the cleaning process. The interior surfaces were surveyed and the lower 12 feet of all wall surfaces were sealed with ALARA paint to fix the remaining surface contamination in place. A contractor was hired to excavate the soil around the building and to saw-cut and demolish the facility in the same manner as was done in FY 1997 for the Hot Laboratory basement. The above-grade portions of the walls were first saw-cut and the wall sections were placed in roll-off containers for off-site disposal. The soil surrounding the remaining structure was then excavated to a depth of 4 feet, as shown in Figure 6-98, and a series of 3-inch-diameter holes was cored through the concrete walls to act as lifting eyes during removal. The trench around the building was then excavated to the base of the structure. The soil was surveyed in 2-foot-depth increments during removal and determined to be radiologically clean.

Figure 6-98. Partial Soil Excavation Around the Building 4468 Below-Grade Structure. [ETEC-6/26/98-395613]

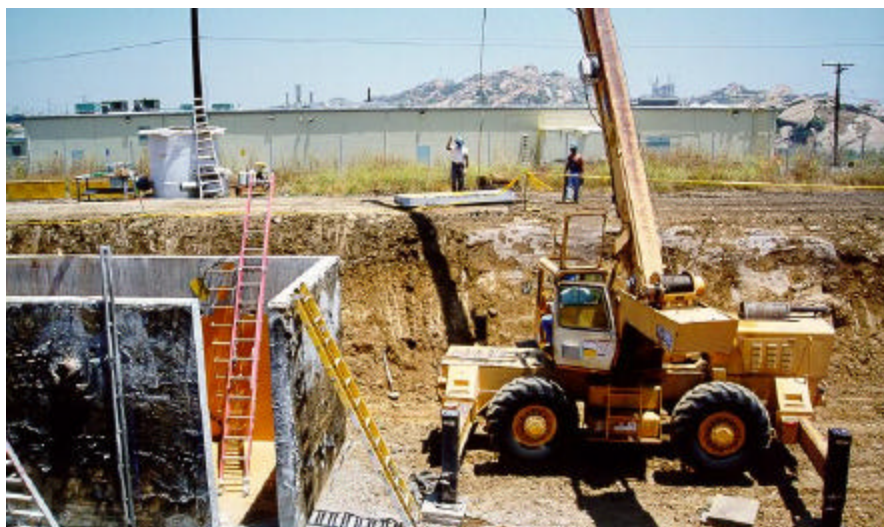
The excavated wall structure was saw-cut by the contractor from the outside, leaving an approximately ¼-inch thickness uncut at the interior surface to ensure that the cutting water did not become contaminated. The individual wall segments were supported using the Rocketdyne mobile crane and a sling through one of the cored holes while the bottom horizontal cut was made. The cut segment was then snapped off and moved to a staging area, where it was double-wrapped in plastic for contamination control. Figure 6-99 shows the removal of one of the wall sections. Twenty-seven wall and floor slab sections were cut and transferred to the RMHF for staging and shipment to a DOE-approved disposal site.

Figure 6-99. Removal of Building 4468 Below-Grade Wall Sections. [ETEC-7/20/98-395663]

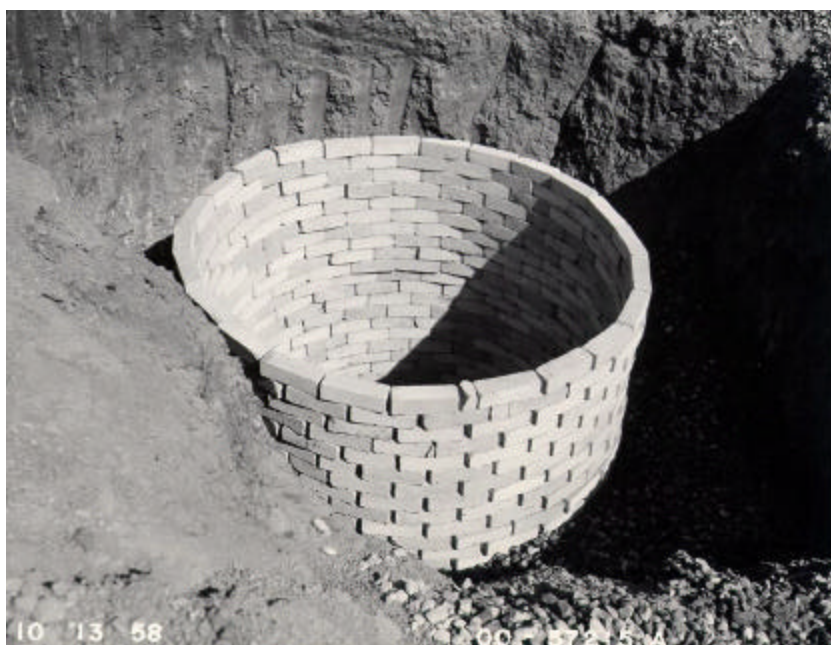
Each of the two leach pits was a cylindrical brick structure, as shown in the Figure 6-100 construction photograph, surrounded by gravel and with a gravel layer on the inside bottom. Excavation of the pits was a slower process, because of the design coupled with concerns over the potential presence of unexpected biological hazards or radioactive contamination. Extensive surveys were made during excavation; both pits were determined to be free of radiological contamination and biological hazards. The bricks from the pits were placed in roll-off containers for disposal as clean waste. The excavation operation is shown in Figure 6-101.

Figure 6-100. Construction Photograph of One of the Two Leach Pits. [00-57215A]

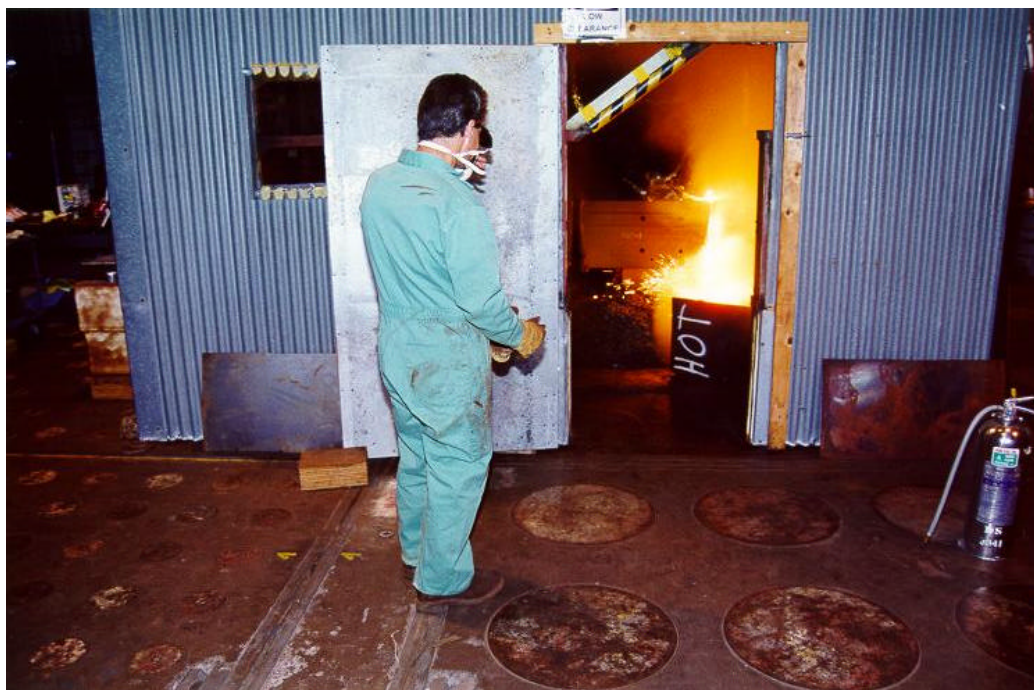
Figure 6-102. Door Cutting Operation in the Steel Penthouse Structure. [ETEC-10/26/98-395696]

Preparations for using the powder torch included the installation of a steel-sided penthouse structure inside the RMHF high bay (Figure 6-102). A high-volume exhaust system was set up and directed through a water spray to reduce the smoke particulate. The cutting torch was track-mounted inside the containment structure, with the gas valves, powder flow, and motor drive controls located outside of the structure.
